**REMOVAL PROGRAM
AFTER ACTION REPORT
FOR THE
ANGLO ENTERPRISES COMPANY SITE
WEBSTER, WORCESTER COUNTY, MASSACHUSETTS
2 AUGUST 2016 THROUGH 21 APRIL 2017**

Weston Solutions, Inc.
Superfund Technical Assessment and Response Team IV (START)
101 Billerica Avenue, Building 5, Suite 103
North Billerica, Massachusetts 01862

July 2017

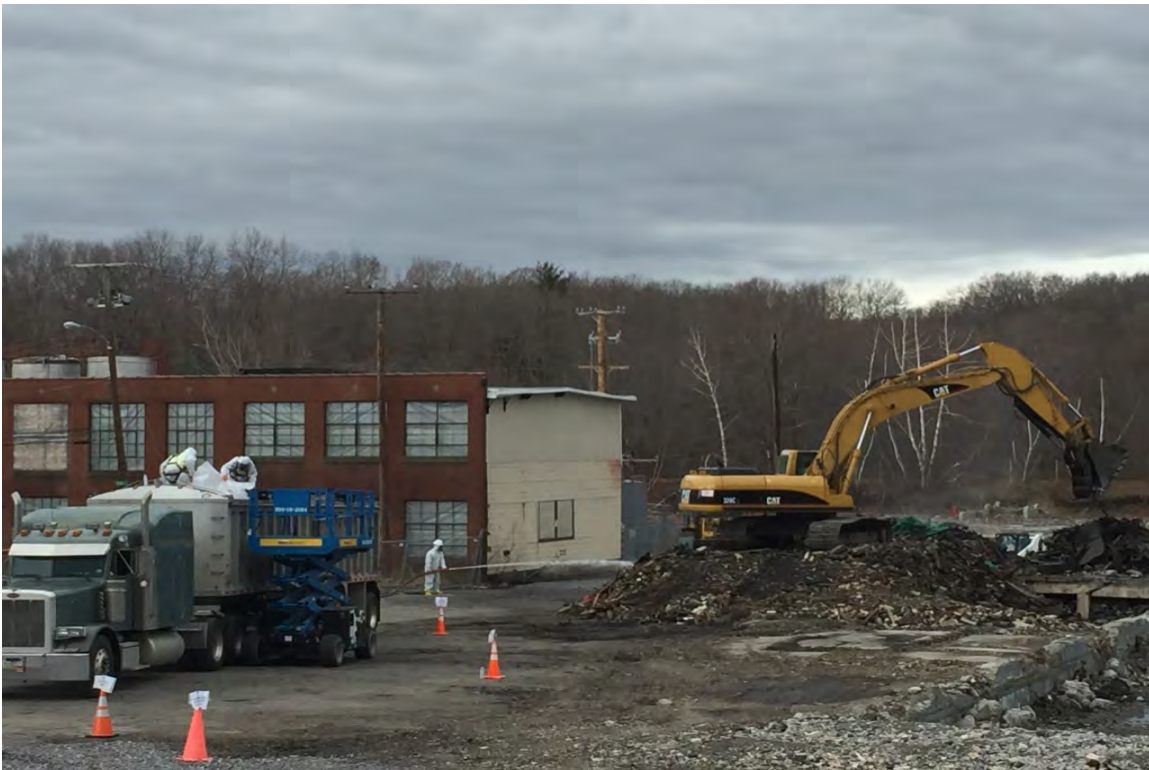
SCENE: View of a trailer being sealed after load out, and the excavator picking out steel pieces as the ACM stockpile is wetted. Photograph taken facing west.

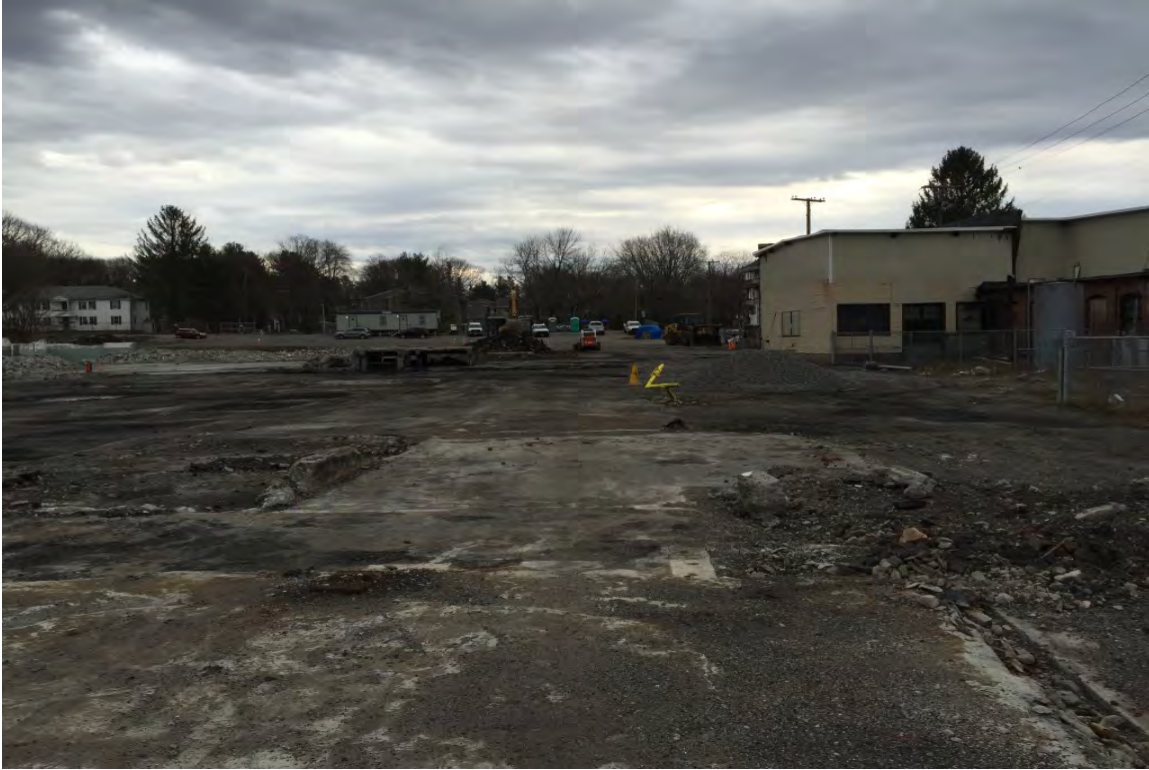
SCENE: View of the remaining load-out stockpile, and the steel natural gas line spray-painted yellow in the middle of the photograph. Photograph taken facing east.

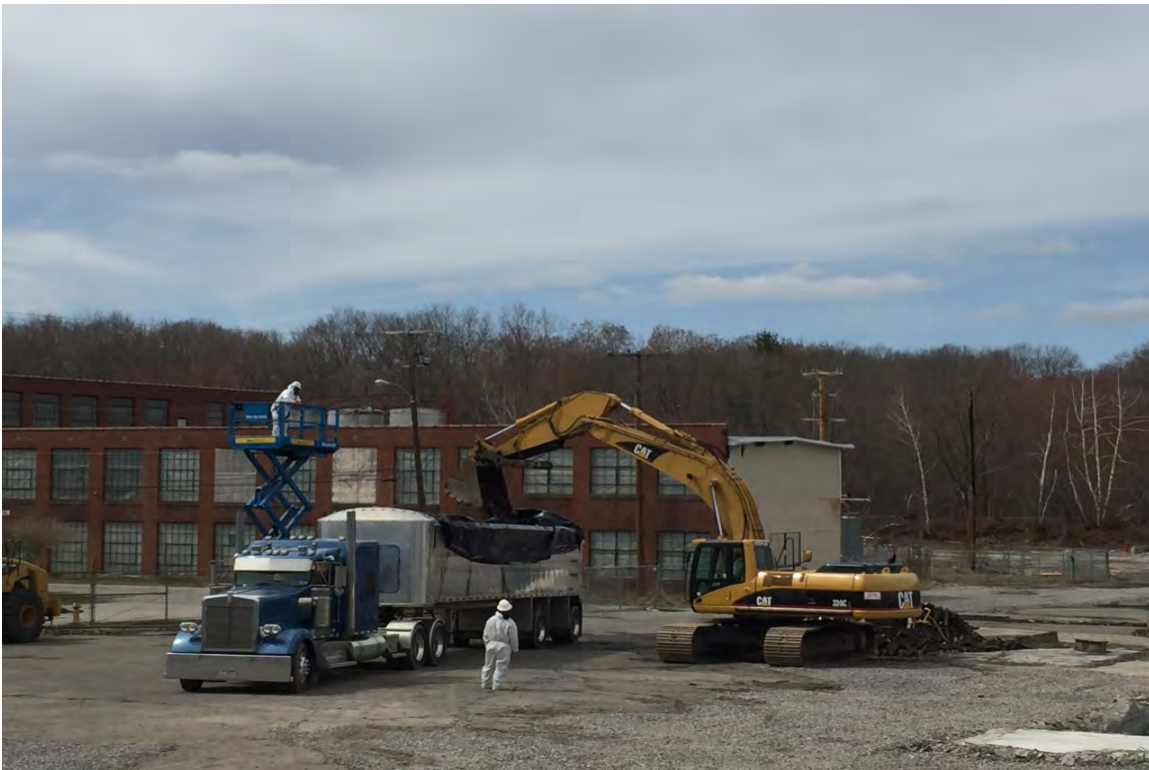
SCENE: View of the scissor lift operator spotting for the excavator operator during load out. Photograph taken facing west.

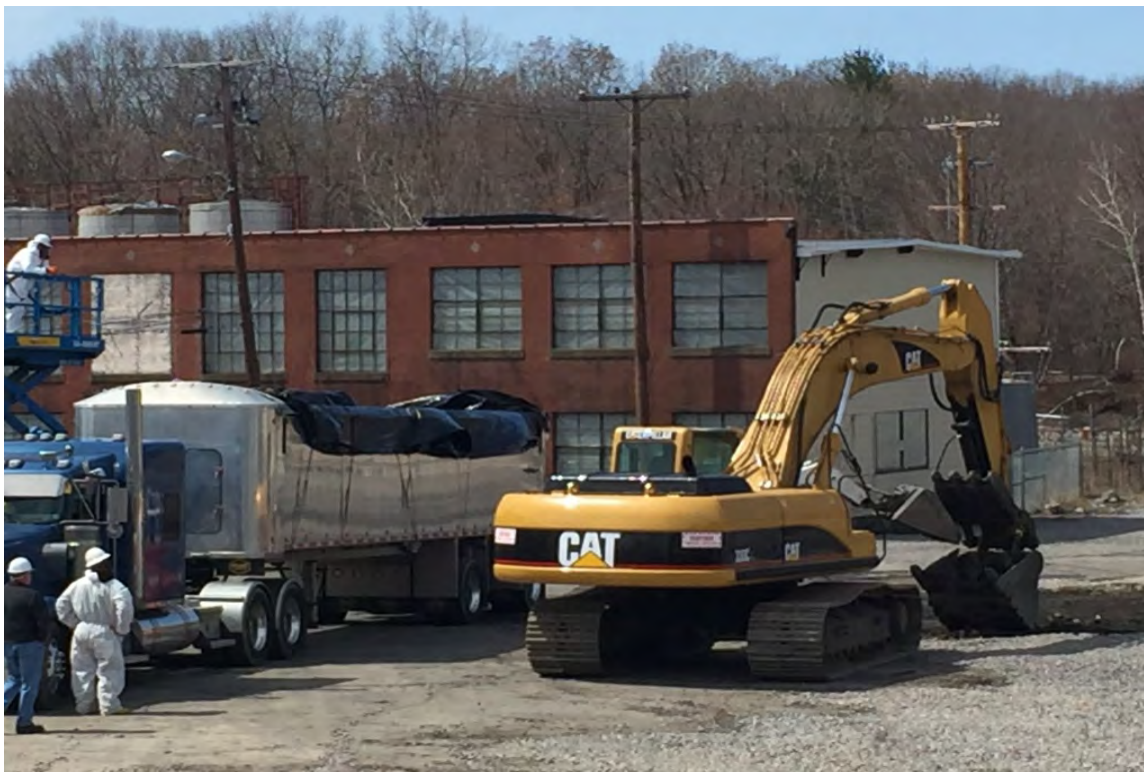
SCENE: View of the scissor lift and skid steer operators assisting with the load out of the last of the ACM debris.
Photograph taken facing west.
